**Flood Control Project Maintenance
Levee Inspections**

Fall 2015 Levee Maintenance Deficiency Summary Report

Levee District No. 0001 (Glenn County)

Waterway			Bank	Unit Miles
Unit No. 01 Sacramento River			Right	12.23
	Spring (March - May)	Summer (June - August)	(September - November) Fall	Winter (December - February)
Unit Maintenance Rating (Fall Only)			M	
Date of Inspection	04/07/2015 - 04/07/2015		09/14/2015 - 09/14/2015	
DWR Inspector	Bob Duffey		Bob Duffey	
Accompanied By	Bill Carriere		Bill Carriere	
			Jason Enos

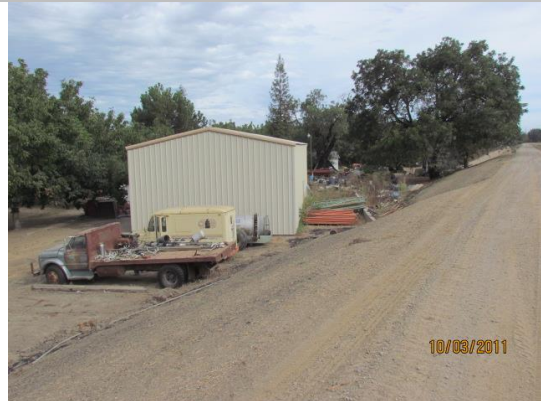
Photo 1 of 1 : FA_2015_LD0001G_432_4_20150910_00002.jpg

LM Start	1.07	Rating **	M	Issue No.	4
LM End	1.30	Issue Type +	En	Location *	LS
Category	Earthen Levee			GPS Latitude/Longitude	
				Start	End
Item	Encroachments			39.491887 °	39.494572 °
				-122.020238 °	-122.017840 °
DWR ID	DWR_LD0001G_01_s_2012_4				
Action/Comments					
Building

View of vehicles & equipment along the L/S toe.

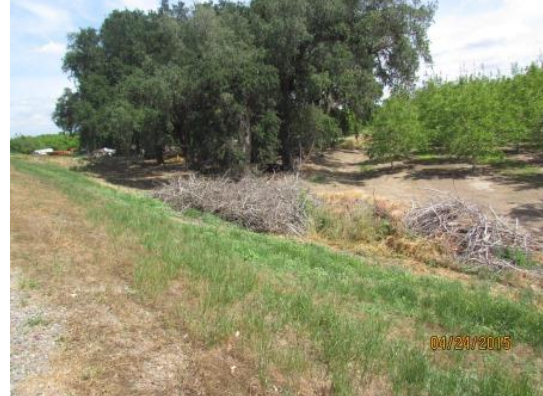
Photo 1 of 1 : FA_2015_LD0001G_432_58_20150910_00023.jpg

LM Start	1.15	Rating **	M	Issue No.	58
LM End	1.15	Issue Type +	En	Location *	WS
Category	Earthen Levee			GPS Latitude/Longitude	
				Start	End
Item	Encroachments			39.492788 °	39.492788 °
				-122.019437 °	-122.019437 °
DWR ID	DWR_LD0001G_01_s_2015_58				
Action/Comments					
Prunings					
Inspector Comments: Remove the prunings from the waterside toe.

View of the prunings along the waterside toe.

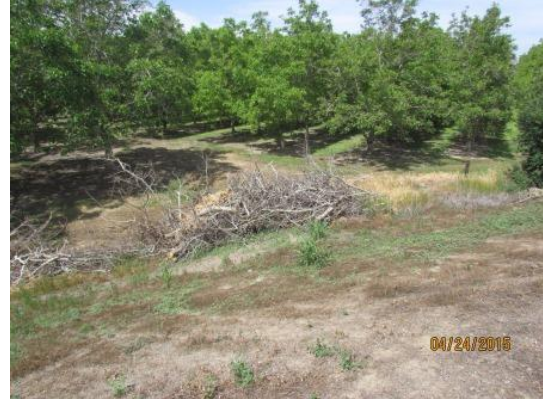
Photo 1 of 1 : FA_2015_LD0001G_432_60_20150910_00025.jpg

LM Start	1.25	Rating **	M	Issue No.	60
LM End	1.25	Issue Type +	En	Location *	LS
Category	Earthen Levee			GPS Latitude/Longitude	
				Start	End
Item	Encroachments			39.494033 °	39.494033 °
				-122.018327 °	-122.018327 °
DWR ID	DWR_LD0001G_01_s _ 2015_60				
Action/Comments					
Prunings					
Inspector Comments: Remove the prunings from the landside toe.

View of the prunings along the landside toe.

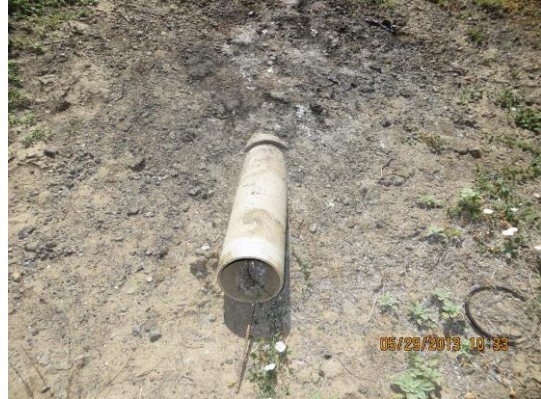
Photo 1 of 3 : UCIP_FA_2015_1034.jpg

LM Start	2.22	Rating **	M	Issue No.	402
LM End	2.22	Issue Type +	En	Location *	LS
Category	Supplemental			GPS Latitude/Longitude	
				Start	End
Item	DWR UCIP Field Study			39.501690 °	39.501690 °
				-122.006099 °	-122.006099 °
DWR ID					
Action/Comments					
Inspector Comments: FS_ID:14332					
DS_ID:22944					
EP_NO: N/A					
FS_HLM: 2.26					
Repair Type: Non-Urgent					
Crossing Status: Found

8-inch pipe sleeved through a 12-inch concrete pipe.

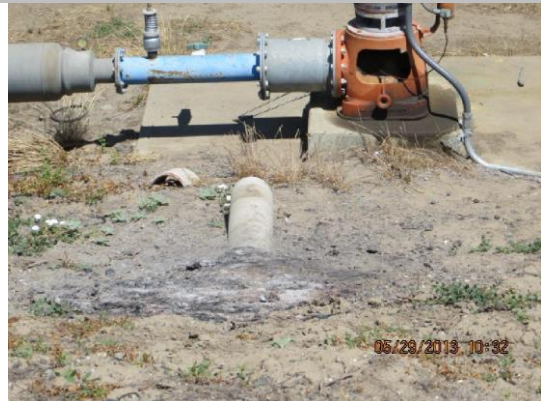
Photo 2 of 3 : UCIP_FA_2015_1035.jpg

Pipe next to pump at LS toe.

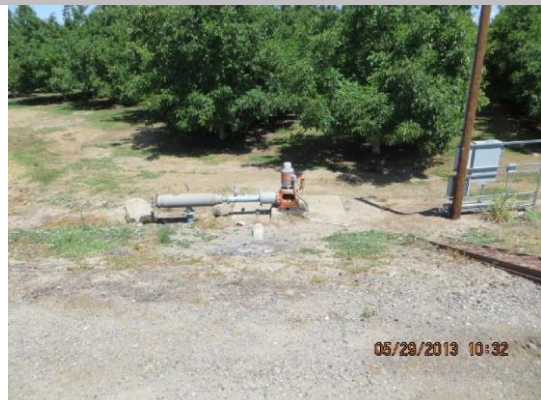
Photo 3 of 3 : UCIP_FA_2015_1036.jpg

Pump at location of pipe on LS toe.

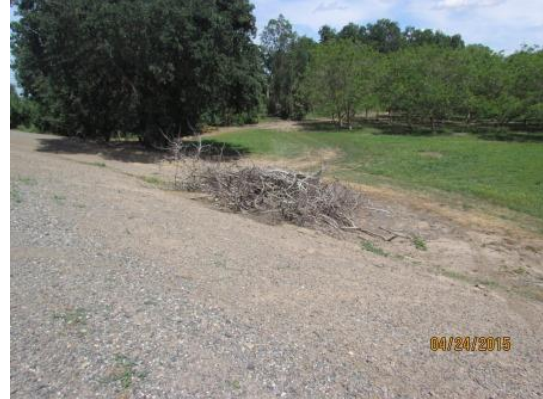
Photo 1 of 1 : FA_2015_LD0001G_432_62_20150910_00027.jpg

LM Start	2.87	Rating **	M	Issue No.	62
LM End	2.87	Issue Type +	En	Location *	WS
Category	Earthen Levee			GPS Latitude/Longitude	
				Start	End
Item	Encroachments			39.510492 °	39.510492
				-122.009023 °	-122.009023
DWR ID	DWR_LD0001G_01_s _ 2015_62				
Action/Comments					
Prunings					
Inspector Comments: Remove the pruning from the waterside toe.

View of the pruning on the waterside toe.

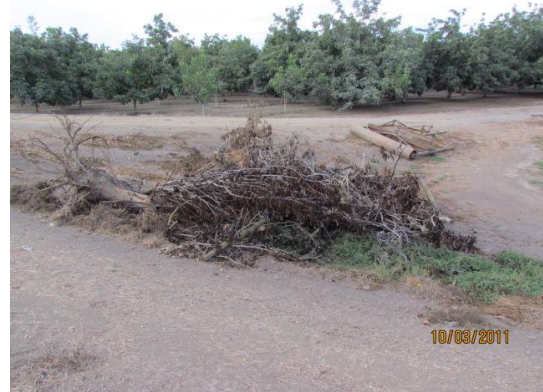
Photo 1 of 1 : FA_2015_LD0001G_432_16_20150910_00008.jpg

LM Start	3.17	Rating **	M	Issue No.	16
LM End	3.17	Issue Type +	Ma	Location *	LS
Category	Earthen Levee			GPS Latitude/Longitude	
				Start	End
Item	Encroachments			39.514378 °	39.514378 °
				-122.010306 °	-122.010306 °
DWR ID	DWR_LD0001G_01_s _ 2012_16				
Action/Comments					
Prunings

View of the pruning pile along the L/S toe.

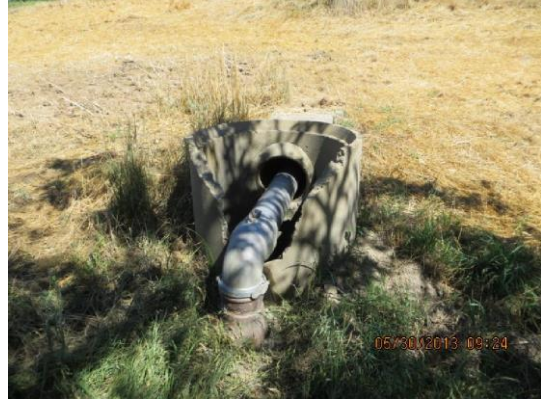
Photo 1 of 3 : UCIP_FA_2015_1037.jpg

LM Start	4.25	Rating **	U	Issue No.	405
LM End	4.25	Issue Type +	En	Location *	LS
Category	Supplemental			GPS Latitude/Longitude	
				Start	End
Item	DWR UCIP Field Study			39.527050 °	39.527050 °
				-122.005247 °	-122.005247 °
DWR ID					
Action/Comments					
Inspector Comments: FS_ID:14343					
DS_ID:22906					
EP_NO: 1229					
FS_HLM: 4.322					
Repair Type: Urgent					
Crossing Status: Found

8-inch pipe sleeved through 16-inch pipe at LS toe.

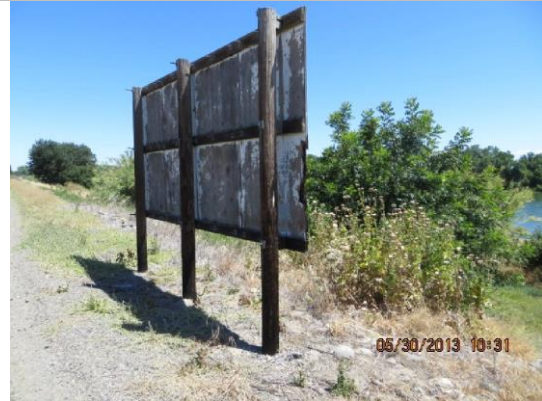
Photo 1 of 2 : UCIP_FA_2015_1040.jpg

Gasline sign on WS shoulder.

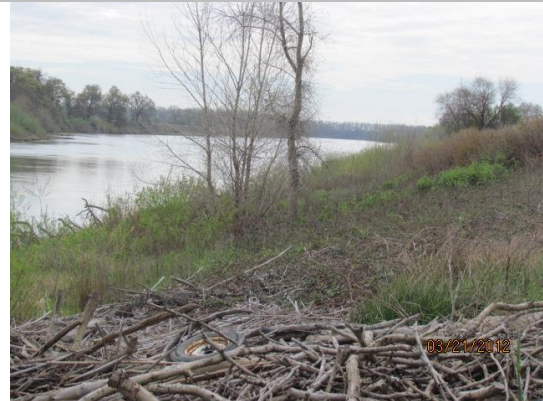
Photo 1 of 1 : FA_2015_LD0001G_432_10_20150910_00006.jpg

LM Start	6.56	Rating **	A/W	Issue No.	10
LM End	6.56	Issue Type +	Ma	Location *	WS
Category	Earthen Levee			GPS Latitude/Longitude	
				Start	End
Item	Vegetation			39.555274 °	39.555274 °
				-122.003505 °	-122.003505 °
DWR ID	DWR_LD0001G_01_s_2012_10				
Action/Comments					
Environmental Requirements.

View of the Army Corps of Engineers mitigation site.

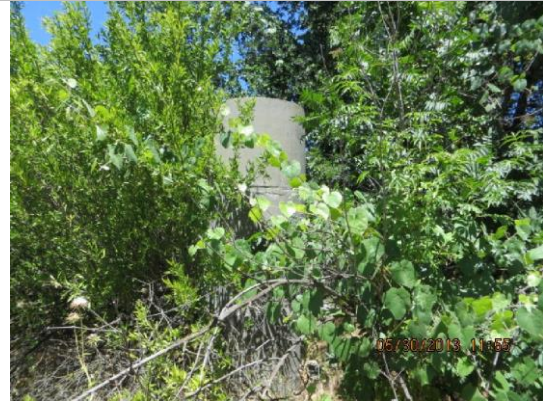
Photo 1 of 3 : UCIP_FA_2015_1108.jpg

Concrete standpipe off WS toe.

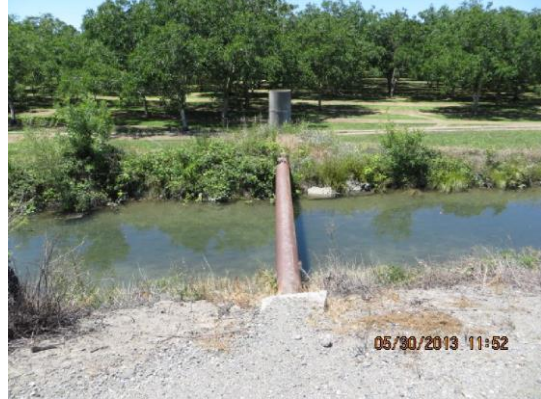
Photo 3 of 3 : UCIP_FA_2015_1110.jpg

LM Start	6.90	Rating **	M	Issue No.	409 (cont)
LM End	6.90	Issue Type +	En	Location *	WS
Category	Supplemental			GPS Latitude/Longitude	
				Start	End
Item	DWR UCIP Field Study			39.560072 °	39.560072 °
				-122.005039 °	-122.005039 °
DWR ID					
Action/Comments					
Inspector Comments: FS_ID:14384					
DS_ID:22917					
EP_NO: 9702					
FS_HLM: 7.005					
Repair Type: Non-Urgent					
Crossing Status: Found

Pipe on LS toe with concrete standpipe visible.

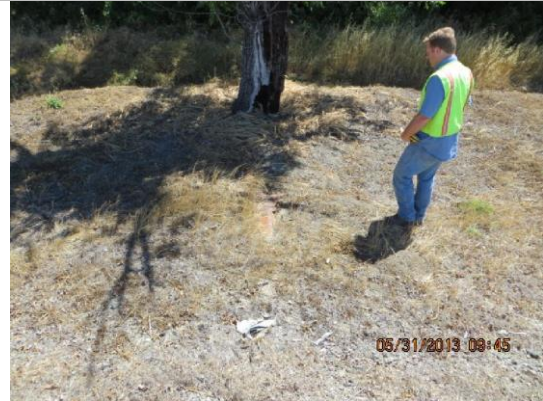
Photo 1 of 3 : UCIP_FA_2015_1111.jpg

Pipe on WS slope.

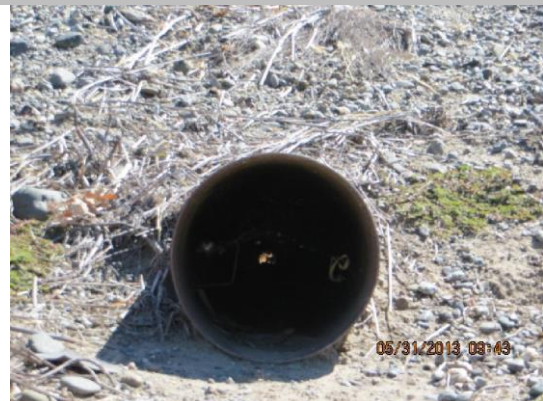
Photo 2 of 3 : UCIP_FA_2015_1112.jpg

Pipe on LS slope.

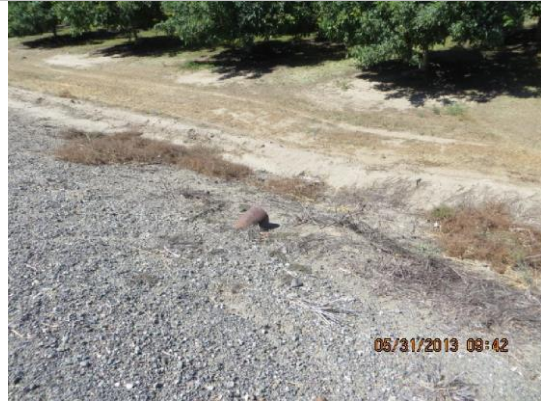
Photo 3 of 3 : UCIP_FA_2015_1113.jpg

LM Start	8.47	Rating **	U	Issue No.	410 (cont)
LM End	8.47	Issue Type +	En	Location *	WS
Category	Supplemental			GPS Latitude/Longitude	
				Start	End
Item	DWR UCIP Field Study			39.582275 °	39.582275 °
				-122.007449 °	-122.007449 °
DWR ID					
Action/Comments					
Inspector Comments: FS_ID:43096					
DS_ID:22918					
EP_NO: 9563					
FS_HLM: 8.59					
Repair Type: Urgent					
Crossing Status: Found

Pipe on LS slope.

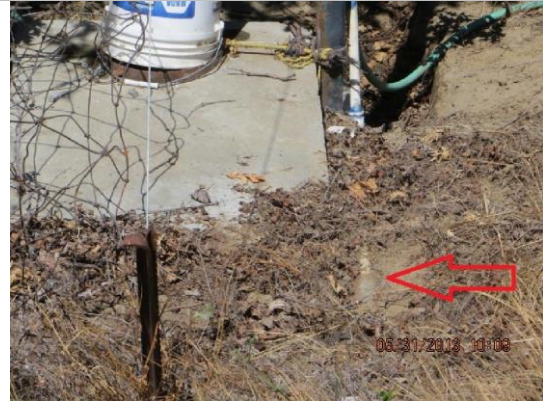
Photo 2 of 3 : UCIP_FA_2015_1411.jpg

Pipe visible next to well with bucket over standpipe.

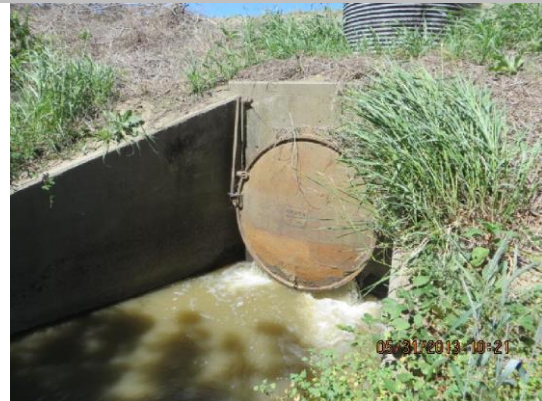
Photo 1 of 3 : UCIP_FA_2015_1114.jpg

Flap gate and headwall on WS toe.

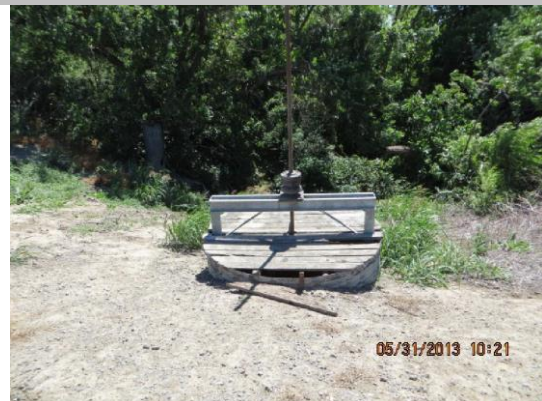
Photo 2 of 3 : UCIP_FA_2015_1115.jpg

Slide gate in 8-foot diameter CMP riser on WS slope.

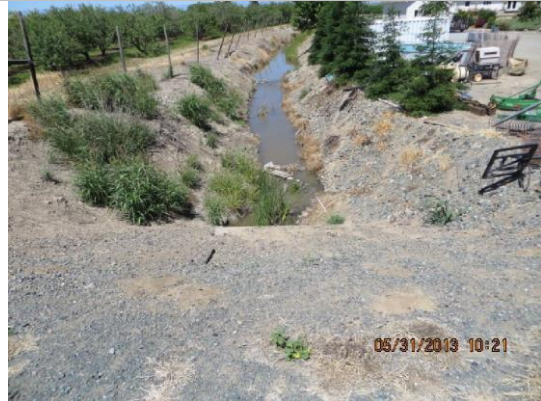
Photo 3 of 3 : UCIP_FA_2015_1116.jpg

LM Start	9.49	Rating **	M	Issue No.	412 (cont)
LM End	9.49	Issue Type +	En	Location *	WS
Category	Supplemental			GPS Latitude/Longitude	
				Start	End
Item	DWR UCIP Field Study			39.596012 °	39.596012 °
				-122.002638 °	-122.002638 °
DWR ID					
Action/Comments					
Inspector Comments: FS_ID:14389					
DS_ID:22920					
EP_NO: 9560					
FS_HLM: 9.625					
Repair Type: Non-Urgent					
Crossing Status: Found

Pipe and headwall at LS toe.

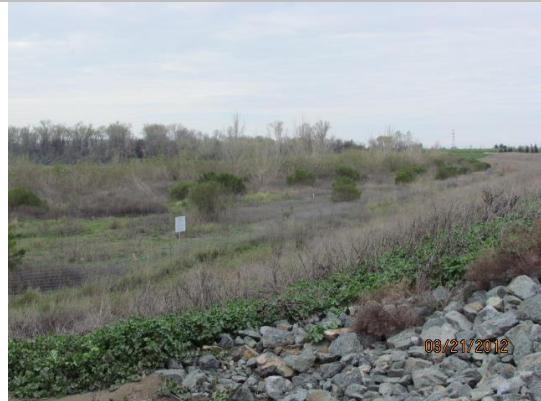
Photo 1 of 1 : FA_2015_LD0001G_432_8_20150910_00005.jpg

LM Start	9.50	Rating **	A/W	Issue No.	8
LM End	10.40	Issue Type +	Ma	Location *	WS
Category	Earthen Levee			GPS Latitude/Longitude	
				Start	End
Item	Vegetation			39.596192 °	39.607288 °
				-122.002573 °	-121.994565 °
DWR ID	DWR_LD0001G_01_s_2012_8				
Action/Comments					
Environmental Requirements.

View of the Army Corps of Engineers mitigation site.

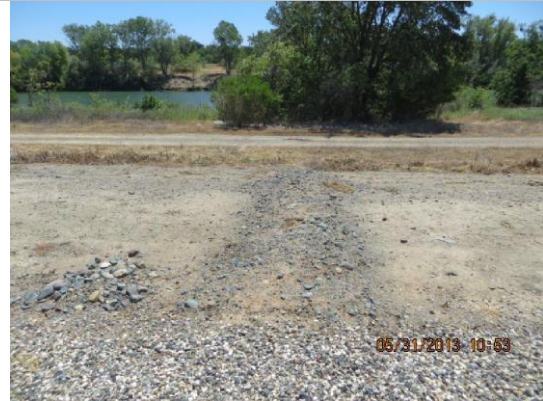
Photo 1 of 3 : UCIP_FA_2015_1413.jpg

Cover over pipe on WS berm.

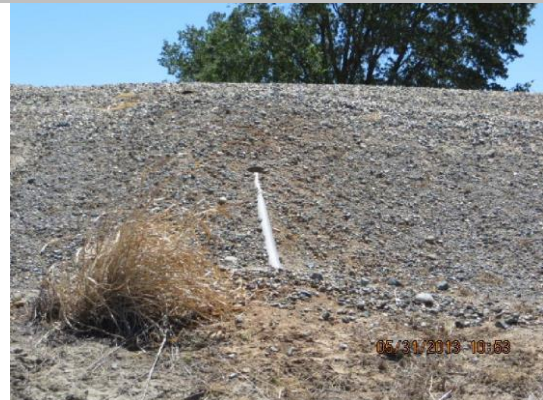
Photo 2 of 3 : UCIP_FA_2015_1414.jpg

Pipe on LS slope.

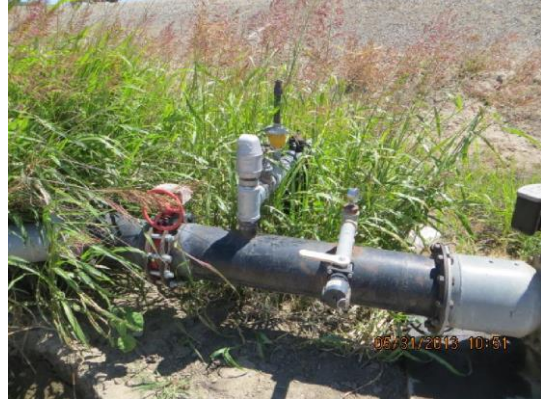
Photo 3 of 3 : UCIP_FA_2015_1415.jpg

LM Start	10.19	Rating **	M	Issue No.	413 (cont)
LM End	10.19	Issue Type +	En	Location *	LS
Category	Supplemental			GPS Latitude/Longitude	
				Start	End
Item	DWR UCIP Field Study			39.604696 °	39.604696 °
				-121.996265 °	-121.996265 °
DWR ID					
Action/Comments					
Inspector Comments: FS_ID:16205 DS_ID:23148 EP_NO: N/A FS_HLM: 10.33 Repair Type: Non-Urgent Crossing Status: Found

Pump with siphon breaker, vent and filter on LS toe.

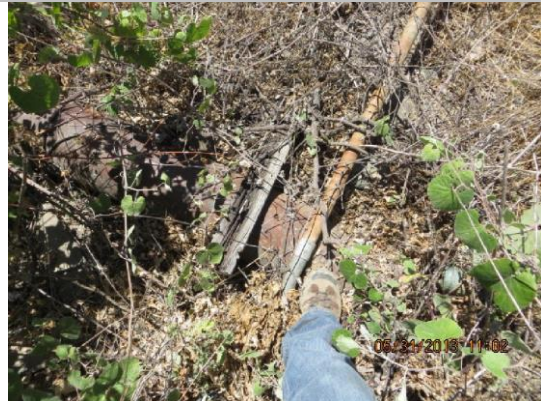
Photo 1 of 2 : UCIP_FA_2015_1307.jpg

LM Start	10.41	Rating **	M	Issue No.	414
LM End	10.41	Issue Type +	En	Location *	LS
Category	Supplemental			GPS Latitude/Longitude	
				Start	End
Item	DWR UCIP Field Study			39.607474 °	39.607474 °
				-121.994410 °	-121.994410 °
DWR ID					
Action/Comments					
Inspector Comments: FS_ID:14562 DS_ID:22938 EP_NO: 9557 FS_HLM: 10.55 Repair Type: Non-Urgent Crossing Status: Found UCIP Comments: Abandoned and should be done so properly. FIELD_STRUCT_DESC: 2 of 2: 1.5 inch galvanized iron electrical conduit through the levee 3.0 feet below the crown (ABO No. 9557, 1974). Originally included in the 1960 O&M manual. FS Date: 05/31/2013

Pipe visible off WS toe.

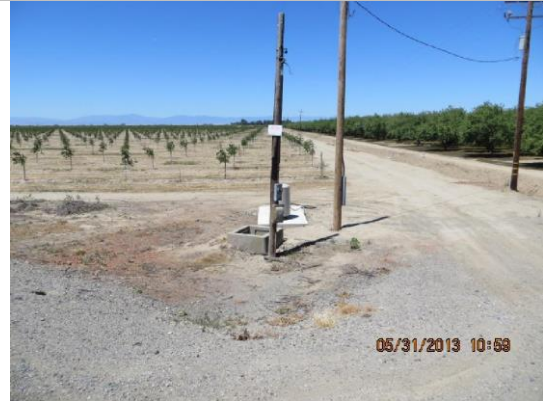
Photo 2 of 2 : UCIP_FA_2015_1308.jpg

Source at JP next to concrete distribution box at LS toe.

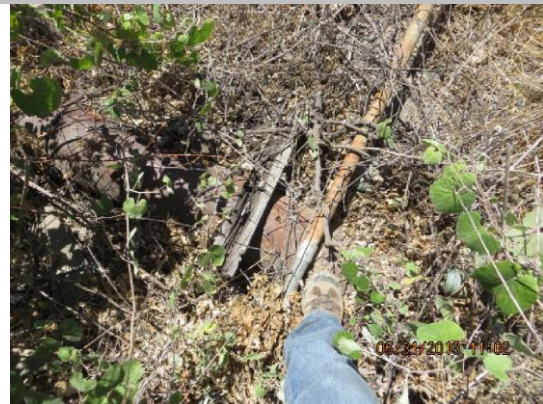
Photo 1 of 3 : UCIP_FA_2015_1285.jpg

LM Start	10.41	Rating **	M	Issue No.	415
LM End	10.41	Issue Type +	En	Location *	LS
Category	Supplemental			GPS Latitude/Longitude	
				Start	End
Item	DWR UCIP Field Study			39.607474 °	39.607474 °
				-121.994410 °	-121.994410 °
DWR ID					
Action/Comments					
Inspector Comments: FS_ID:14561 DS_ID:22923 EP_NO: 9557 FS_HLM: 10.55 Repair Type: Non-Urgent Crossing Status: Found UCIP Comments: This pipe appears abandoned and should be done so properly. FIELD_STRUCT_DESC: 1 of 2: 10-inch pipe through levee 3.7 feet below crown. Pump on bank. Siphon breaker on waterward berm. One corrugated metal cutoff wall. Concrete distribution box at toe of landward slope (ABO No. 9557, 1974). Originally included in the 1960 O&M manual. FS Date: 05/31/2013

10-inch steel pipe and 1.5-inch electrical conduit on WS slope.

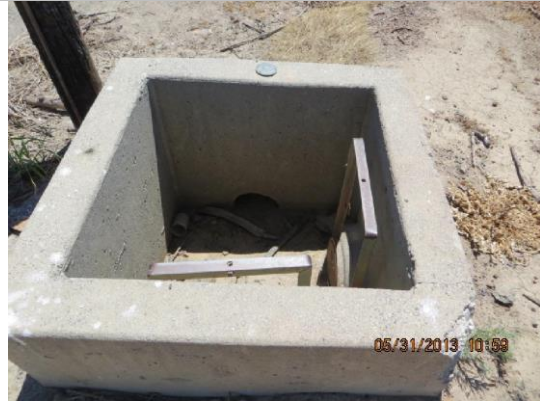
Photo 2 of 3 : UCIP_FA_2015_1286.jpg

Concrete distribution box at LS toe with outlet from pipe through levee.

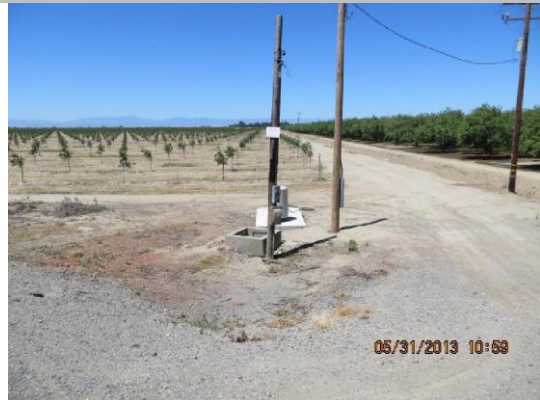
Photo 3 of 3 : UCIP_FA_2015_1306.jpg

Concrete distribution box at LS toe.

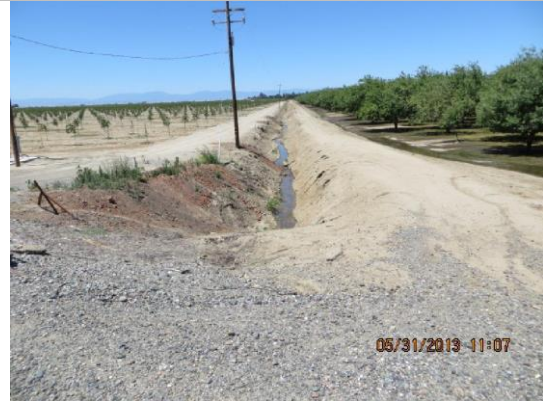
Photo 1 of 3 : UCIP_FA_2015_0960.jpg

LM Start	10.43	Rating **	U	Issue No.	416
LM End	10.43	Issue Type +	En	Location *	LS
Category	Supplemental			GPS Latitude/Longitude	
				Start	End
Item	DWR UCIP Field Study			39.607688 °	39.607688 °
				-121.994278 °	-121.994278 °
DWR ID					
Action/Comments					
Inspector Comments: FS_ID:41784					
DS_ID:22924					
EP_NO: 9556					
FS_HLM: 10.567					
Repair Type: Urgent					
Crossing Status: Found

Drainage channel on LS toe.

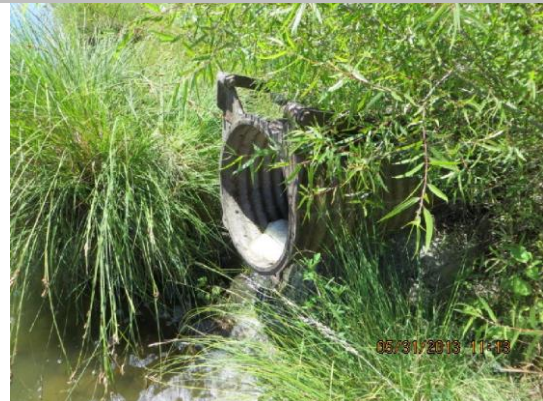
Photo 2 of 3 : UCIP_FA_2015_1309.jpg

Pipe and flapgate at WS toe.

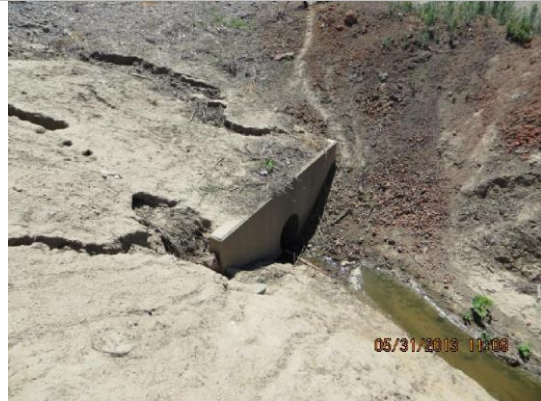
Photo 3 of 3 : UCIP_FA_2015_1310.jpg

Concrete headwall and pipe at LS toe.

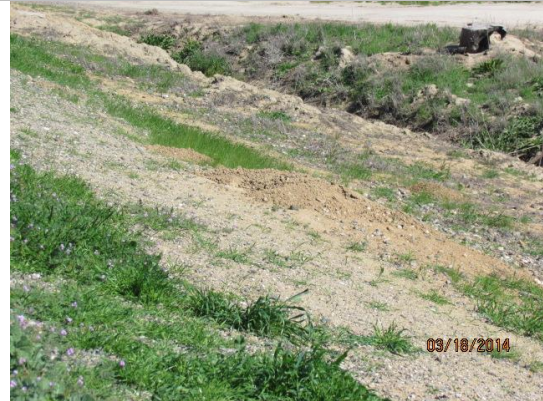
Photo 1 of 1 : FA_2015_LD0001G_432_48_20150910_00013.jpg

LM Start	11.55	Rating **	M	Issue No.	48
LM End	11.55	Issue Type +	Ma	Location *	WS
Category	Earthen Levee			GPS Latitude/Longitude	
				Start	End
Item	Animal Control			39.622652 °	39.622652
				-121.999185 °	-121.999185
DWR ID	DWR_LD0001G_01_s _ 2014_48				
Action/Comments					
No rodents visible, but rodent burrows visible; need to backfill and compact or grout burrows.

View of the rodent activity along the waterside slope.

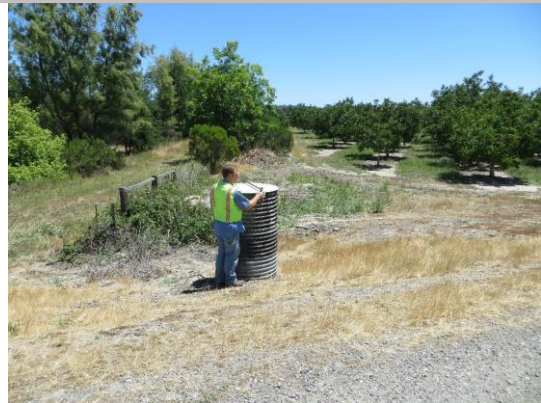
Photo 2 of 3 : UCIP_FA_2015_0962.jpg

Slide gate in CMP riser on WS toe.

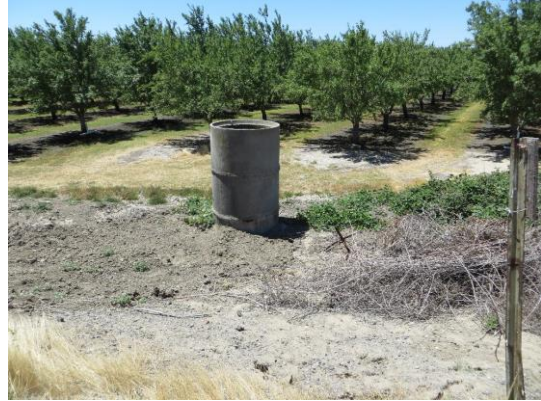
Photo 3 of 3 : UCIP_FA_2015_0963.jpg

Concrete standpipe on LS toe.

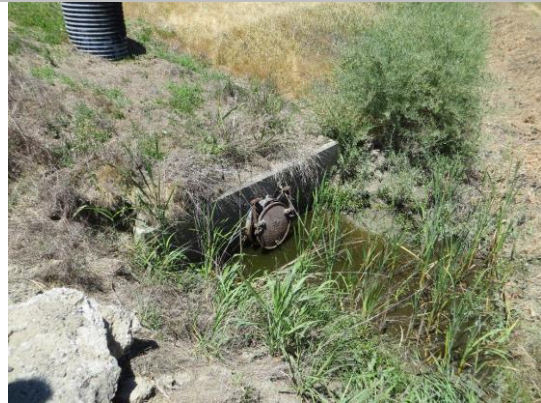
Photo 1 of 3 : UCIP_FA_2015_0964.jpg

Headwall and flapgate on WS toe.

Inspector Comments: FS_ID:14569
 DS_ID:22928
 EP_NO: 9554
 FS_HLM: 12.022
 Repair Type: Non-Urgent
 Crossing Status: Found
 UCIP Comments: Flap gate heavily corroded. Good candidate for video inspection. Vegetation interfering with inlet.
 FIELD_STRUCT_DESC: 24-inch corrugated metal pipe through levee 7.0 feet below crown. Flap gate on waterward end. Slide gate in 36-inch corrugated metal pipe riser on waterward slope. Concrete headwalls on both ends. Two corrugated metal cutoff walls (ABO No. 9554, 1974). Originally included in the 1960 O&M manual.
 FS Date: 05/31/2013

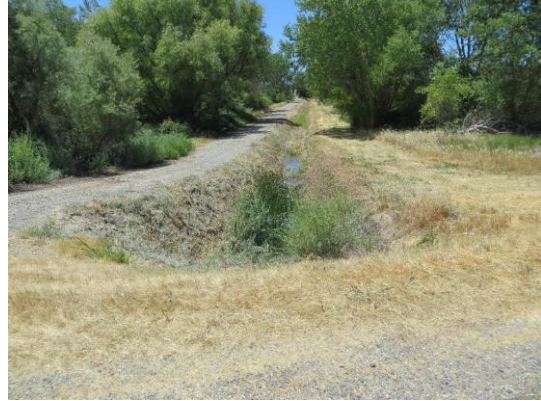
Photo 2 of 3 : UCIP_FA_2015_0965.jpg

Drainage channel on LS toe.

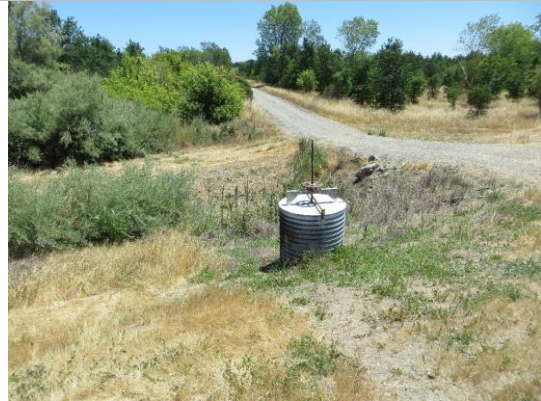
Photo 3 of 3 : UCIP_FA_2015_0966.jpg

Slidegate in 36-inch CMP riser on WS slope.
